# Manhole Inspection Summary

Manhole # S47W1\_014MH

Record Plat: **47W1** Node: **014** Status: **New Manhole (Not in GIS)** Insp Date: **4/19/09 12:55 PM**

**Location** Address: **1273 Chesapeake**

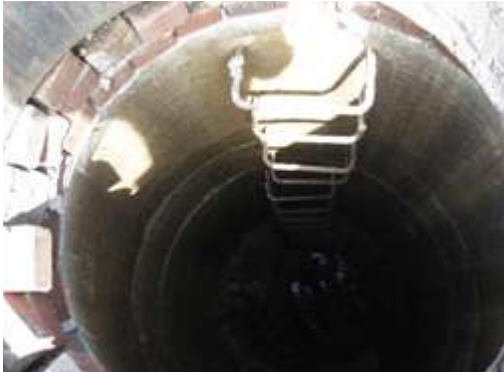
Steps

Count: **10** Missing: **0** ☐ Corroded

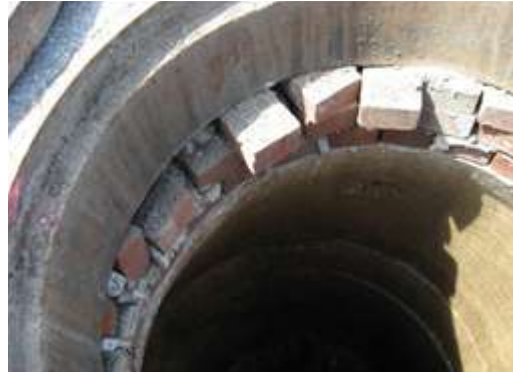
Defect 1

Condition: ☐ Sound ☐ Cracked ☐ Root Intrusion ☒ **Loose Brick** ☐ Deteriorated

Infiltration: ☐ None ☒ **Joint** ☒ **Cracks** ☐ Mortar ☐ Roots ☐ Wall

Loose Bricks in Chimney

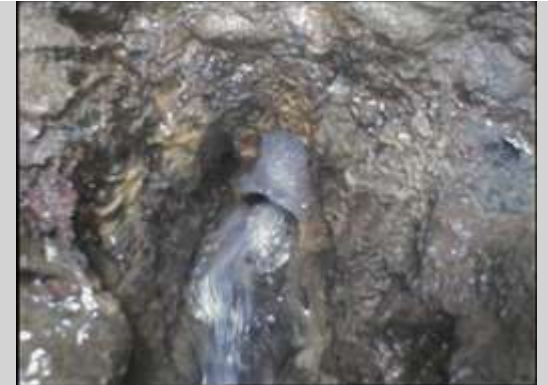
12 O'Clock Outflow

8 in. Circular Gravity Sewer  
Pipe Out @ 12 O'Clock

Pipe Height: **9.6** (in.) Rod and Bar (Angled)  
Pipe Material: **Unknown** ☐ Pipe Lined  
Invert Depth: **16.95** (ft.) Flow Characteristics: **Slow**  
Deposits: ☐ None ☐ Mud ☐ Gravy ☒ **Debris** ☐ Grease  
Silt Depth: **6** (in.) Deposits Extent: **Heavy**  
Infiltration: **Evidence** Pipe Seal Cond: **Cracked**

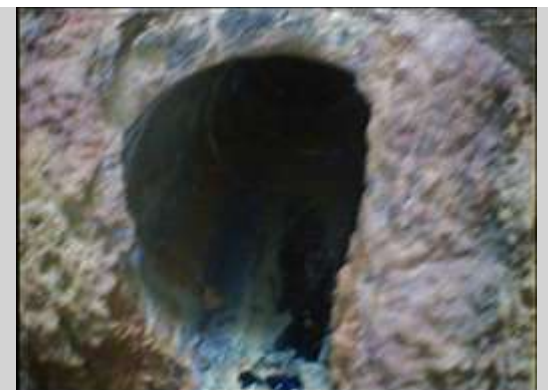
3 O'Clock Inflow

8 in. Circular Gravity Sewer  
Pipe In @ 3 O'Clock

Pipe Height: **9.6** (in.) Rod and Bar (Angled)  
Pipe Material: **Unknown** ☐ Pipe Lined  
Invert Depth: **11.00** (ft.) Flow Characteristics: **Slow**  
Deposits: ☐ None ☐ Mud ☐ Gravy ☒ **Debris** ☐ Grease  
Silt Depth: **6** (in.) Deposits Extent: **Heavy**  
Infiltration: **Evidence** Pipe Seal Cond: **Broken**

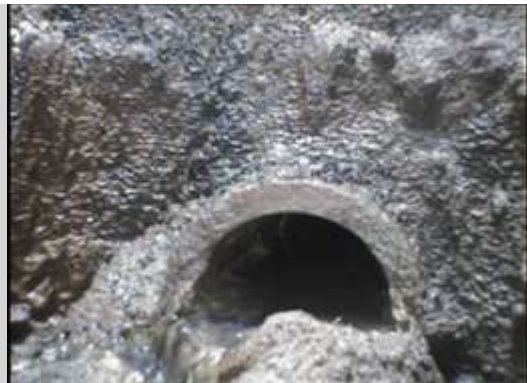
9 O'Clock Inflow

Pipe In @ 9 O'Clock

Deposits: ☐ None ☐ Mud ☒ **Sludge** ☒ **Debris** ☐ Grease

Silt Depth: **6** (in.) Deposits Extent: **Heavy**

Infiltration: **Evidence** Pipe Seal Cond: **Sound**
